Technical Report No. 704021703504-01

Type of Product : Flood lights (Work Light)

Model/Type : 98A03; 98A05; 98B03-AD; 98B05-AD; 98C05; 98C03-2; 98C05-2;
98C03

Purpose of examination : IK 08 test for enclosure

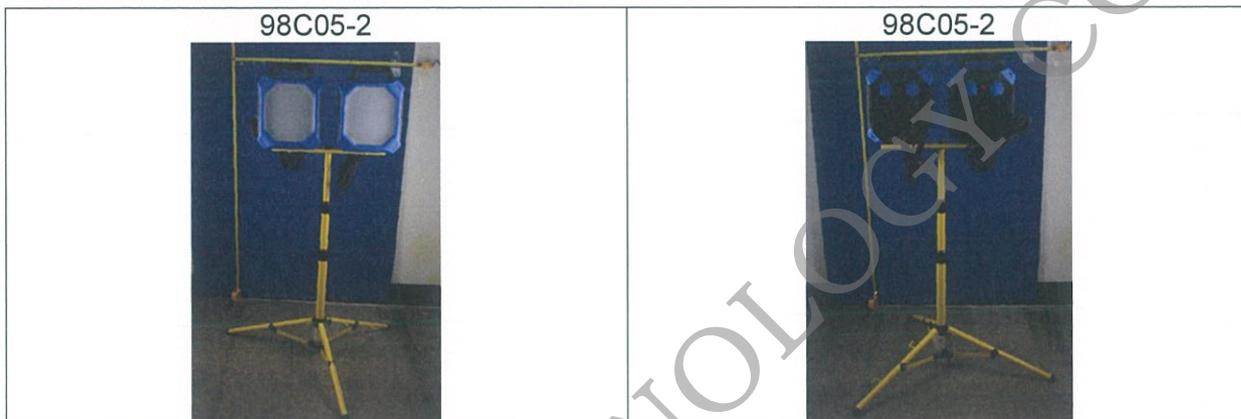
Photo documentation:

Impact energy: 5J

Impact positions: Refer to the picture

Visual inspection: Check if breakage, crack, and separation occur.
